STRENGTHENING ARMENIAN CHURCHES: SOME INNOVATIVE PROPOSALS

LORENZO JURINA

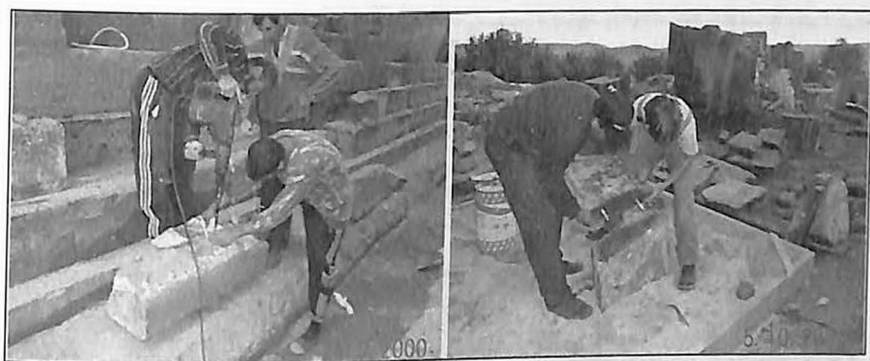
Fig. 3: Big stones are pinned each other

Finally, some big stones were pinned each other, by means of steel bars (Figure 3), to guarantee the mutual connections between the blocks and to increase the resistance of the masonry.

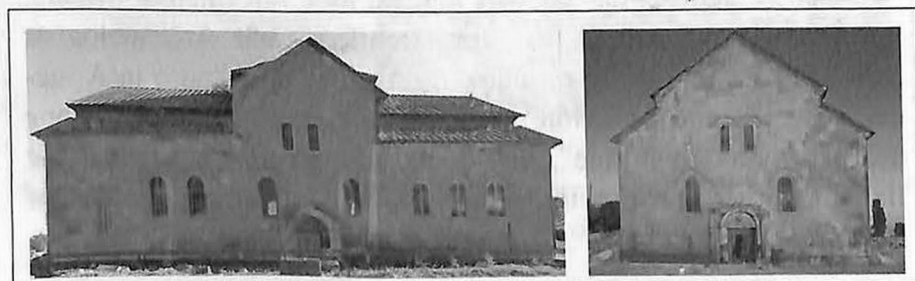
Fig. 5: The thermography applied to the walls provided significant information about the masonry

An accurate diagnosis has been carried-out, applying both in-situ tests (sonic tests, thermography, crack opening monitoring) and laboratory tests, in order to analyze the chemical and mechanical properties of constituent materials (Figure 5).

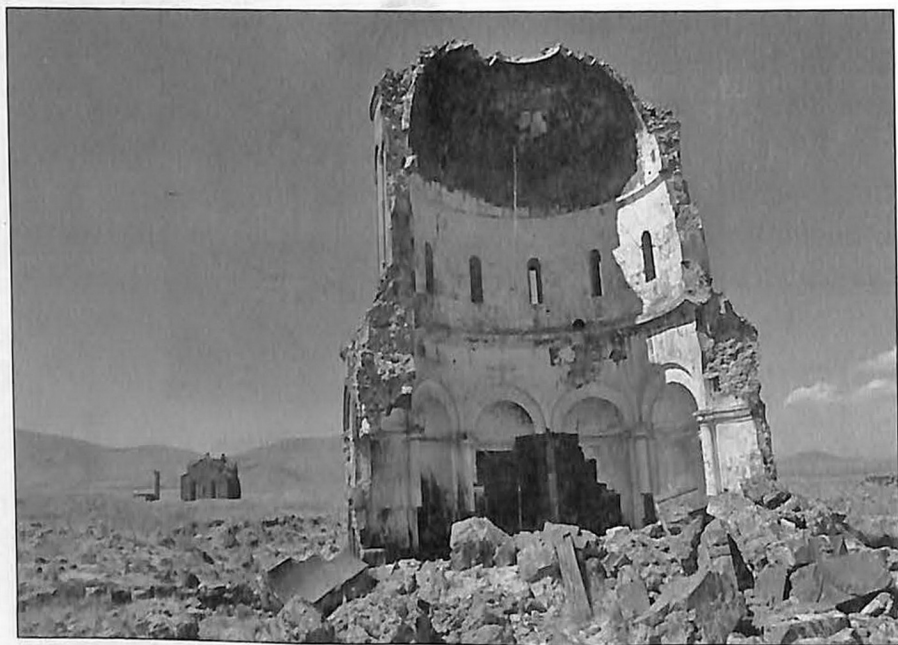
Fig. 9: Ruins of the ancient church of the Savior in Ani

The ancient church of S. Amenaprgitch in Ani (today located in Turkey) represents another interesting case of "ruined" very precious structure. The only part that is still standing corresponds to the apse. The remaining portion of the building collapsed due to a strong earthquake (Figure 9).
