DAVID KERTMENJIAN\*

## ON THE PROTECTION OF THE ARMENIAN STONE-BUILT ARCHITECTURAL MONUMENTS

*Key words:* global climate changes, conservation, Armenian architecture, architectural monument, geology, mortar, composition.

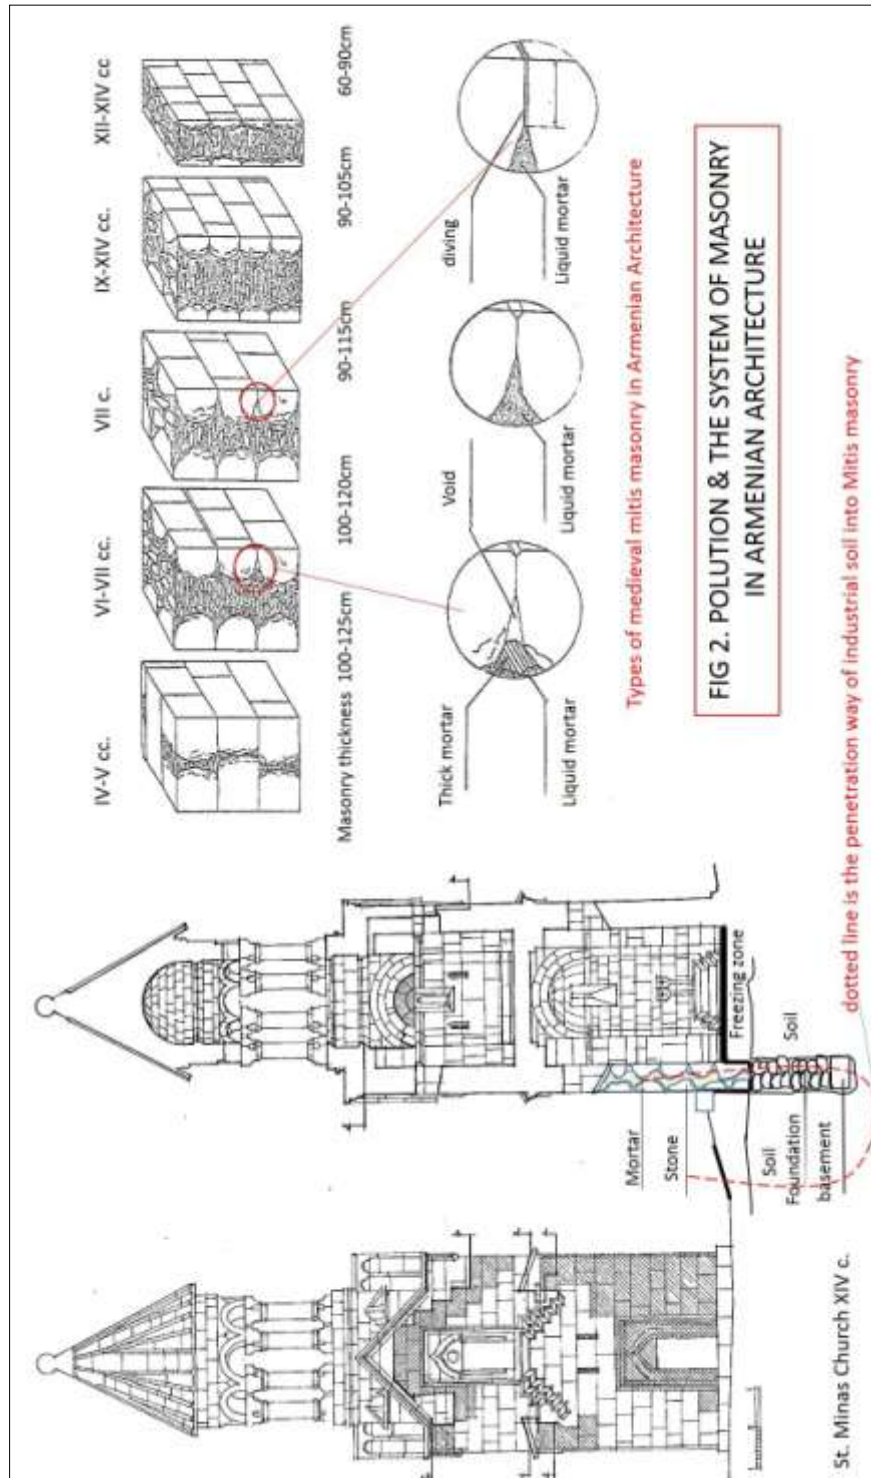
III. Of the building materials used in the Armenian monuments very important are the observed characteristics of the mortars<sup>12</sup>. That is because of the “Midis” masonry used in the medieval Armenian monuments as mentioned above (Fig.1). However, all the historical monuments, with only few exceptions, are built of Midis type masonry consisting of three layers: an inner masonry, external masonry and the mortar between them called “Xibar”. The mortar is a mixture of cement and medium size gravel. The thickness of the wall at minimum is 60cm. and at maximum 125 cm., actually the size and technology differ from those in ancient time and later periods. The side stones gradually decreased but the mortar part increased. Such regularity occurs as a result of diminution of stone size used. The ancient period masonry in Armenia was in dry order. The use of mortar added plasticity which was very important to perform curvilinear forms (dome, vault, arches of different types). Related to the mentioned, the technologies gained experience in an empiric way, which is important from the point of conservation<sup>13</sup>.
